We got some reports that NR board upgrading has problem, some users report the BT menu disappeared after the NR board upgrading, and the NR version is null in the device setting, radio can't enter into the NR board upgrading any more.

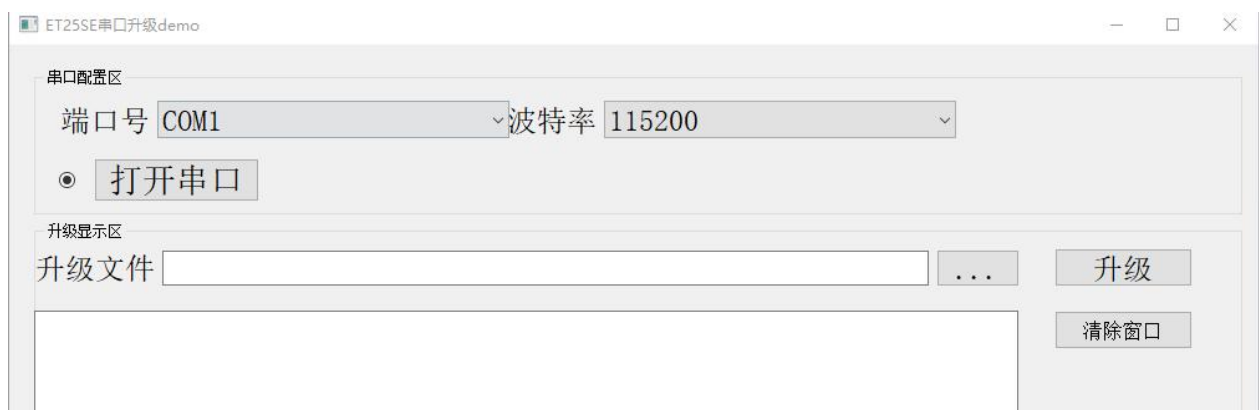
The reason is the power supply disconnects during the NR board upgrading, not sure the reason of the power supply disconnection..

1. Update the radio to be V1.05 or afterwards firmware.
2. Press and hold both top key (PF3) and side PF1 key, and power the radio ON.
3. Run the ET25SE_uart_upgrade.exe

Select the com port and check on the box below the comport select frame

Open the D890_NR_BOARD_V112_20260306.ufw firmware

Load the NR firmware to the radio

4. Reboot the radio, the BT menu should be back.
